Update September 2005

The University of Rhode Island's Permeable Parking Lots

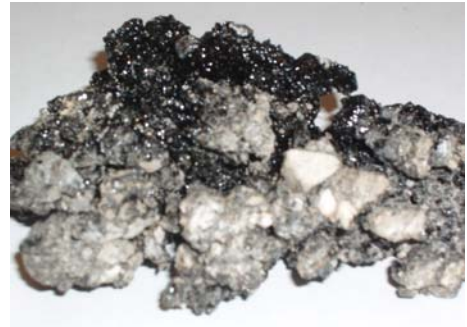
Some clogging of the permeable surface was observed, especially in highly trafficked areas and, to some extent, in areas where snow was stockpiled during the winter. In addition, excavation at the edge of the parking lot for construction of a new sidewalk in July 2005, revealed that the permeable asphalt layer had become tacky and soft, apparently due to separation of the binder from the aggregate. (See Figure 6.) This resulted in sediment collecting at the surface, at a depth of approximately 1/16" thick. This sedimentation and tackiness is inhibiting infiltration. Cahill Associates suggested that the use of an improved mixture that includes the polymer Styrene-Butadiene-Styrene should prevent separation of the binder and eliminate tackiness.

Figure 6: Clogged Layer of Porous Asphalt

While this new porous asphalt mixture is recommended for future construction projects, it is likely that the cost of replacing the current asphalt on the parking lots would be prohibitive.

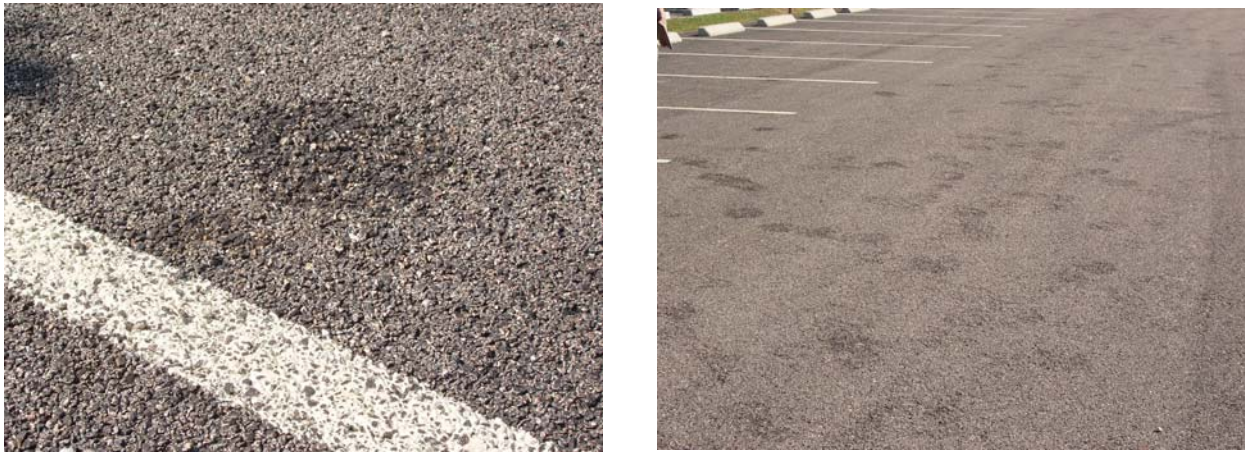
Some surface defects were observed on the parking lot. (See Figure 7.) This might be attributed, at least partially, to plowing, since it is uncertain whether the winter maintenance personnel were setting the plow blade 1" above normal use, as recommended by Cahill Associates. Since that time, additional recommendations were provided to URI personnel, so it is hoped that this can be

Figure 7. Surface defects have appeared within the parking lots. The left photo shows a close-up view, while the right photo shows a particularly damaged area.

corrected. However, it is also recommended that URI personnel investigate the progression of surface defects, after the plowing height is corrected, in order to determine if there are other causes.

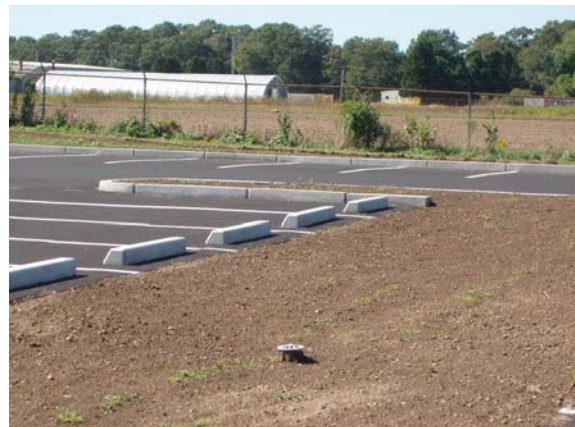
- fewer, wider infiltration islands (See Figure 8 right.)
- curb cuts for water entry to island bioinfiltration areas
- mowed grass, not meadow grasses for islands
- fewer wheel stops, where possible

Figure 8. Wider infiltration islands are connected to conventional islands.
