The University of Rhode Island Porous Asphalt Parking Lots

NEMO U 5 – Middletown, CT

**Lorraine Joubert and Lisa DeProspero Philo
University of Rhode Island Cooperative Extension
Nonpoint Education for Municipal Officials**

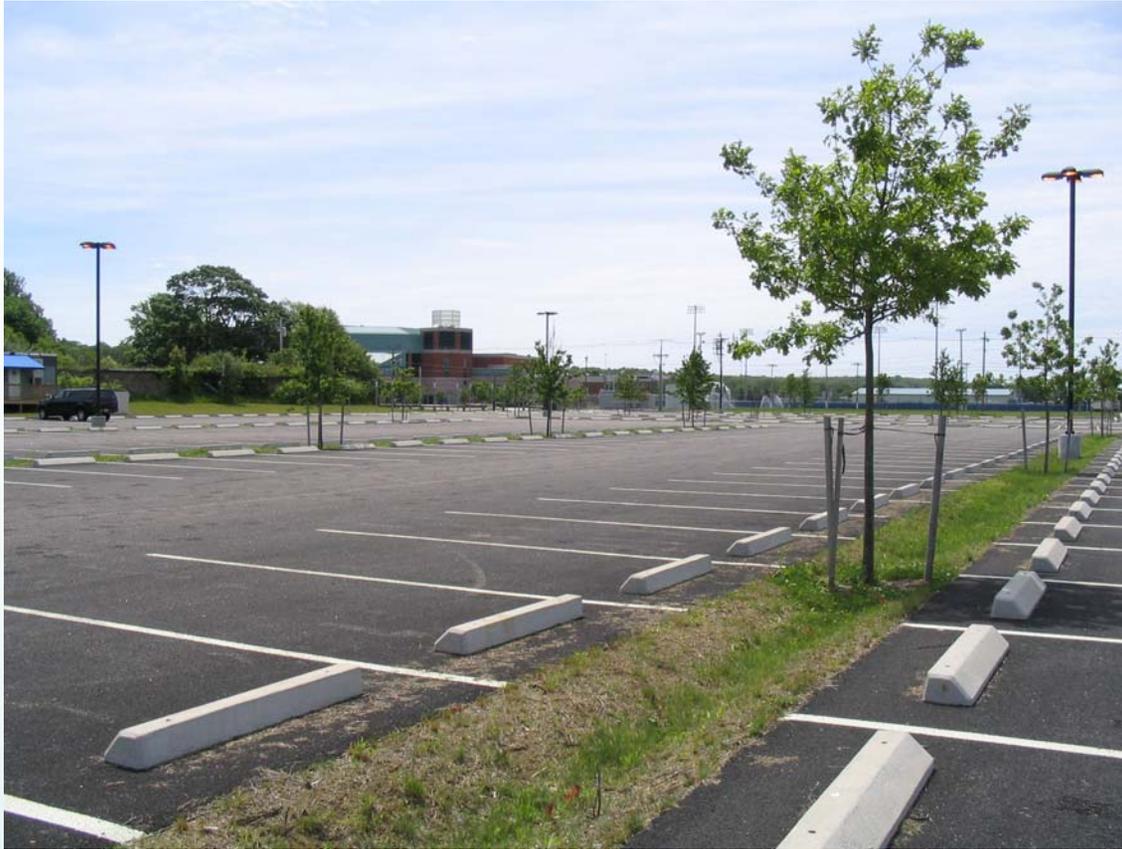
Two Porous Asphalt Parking Lots

Built Fall 2002 & 2003.

**Full use since Fall 2004
with student and
event parking.**

- **800 vehicle lot at
Plains Road (Ryan
Center) 5.5 acres**
- **200 vehicle lot W.
Alumni Ave (Dairy
barn) 1.5 acres.**

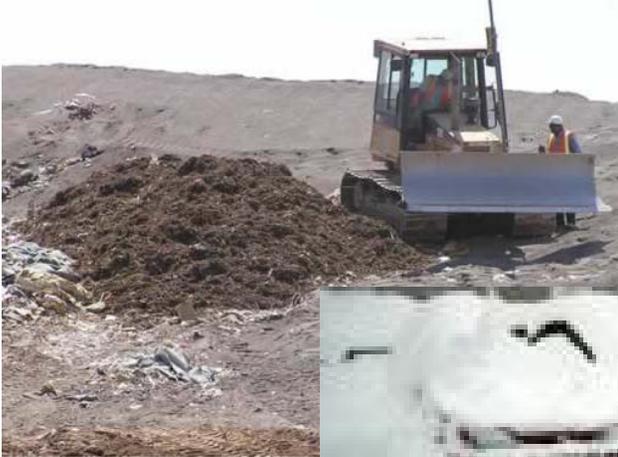
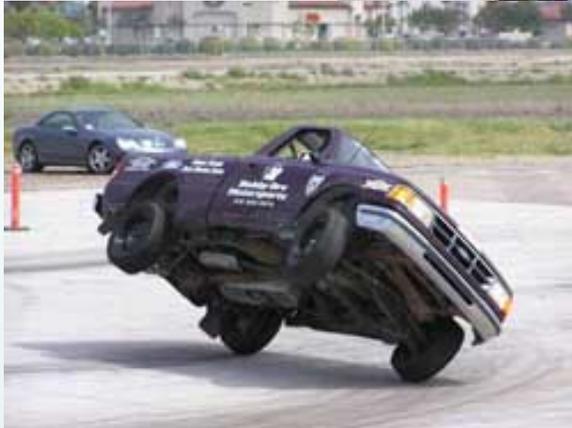
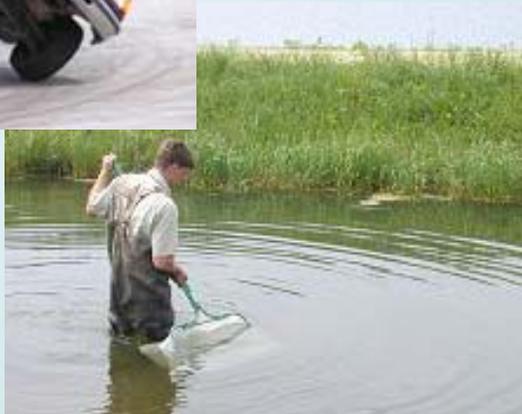
Porous
Pavement
Parking Lots

Practical Benefits

- Cost comparable by avoiding closed drainage system, topsoil use.
- Space savings by eliminating surface stormwater treatment
- Winter snow and ice usually melt and drain more easily
- Improvement of wet pavement skid resistance
- Pedestrians and motorists do not have to contend with large puddles

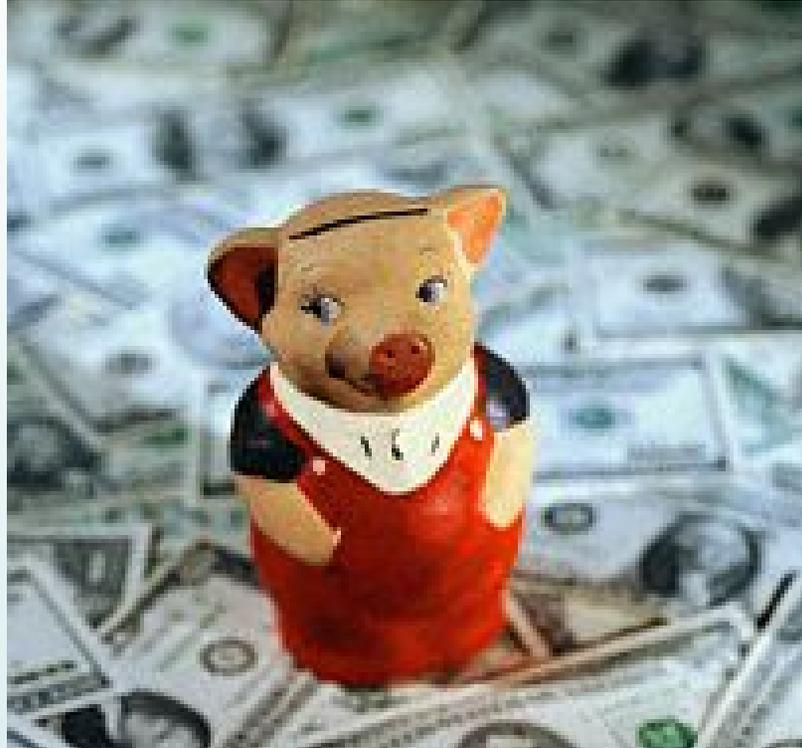
A Note About Costs

- Typical porous pavement averages \$2,200 to \$2,750 per parking space.

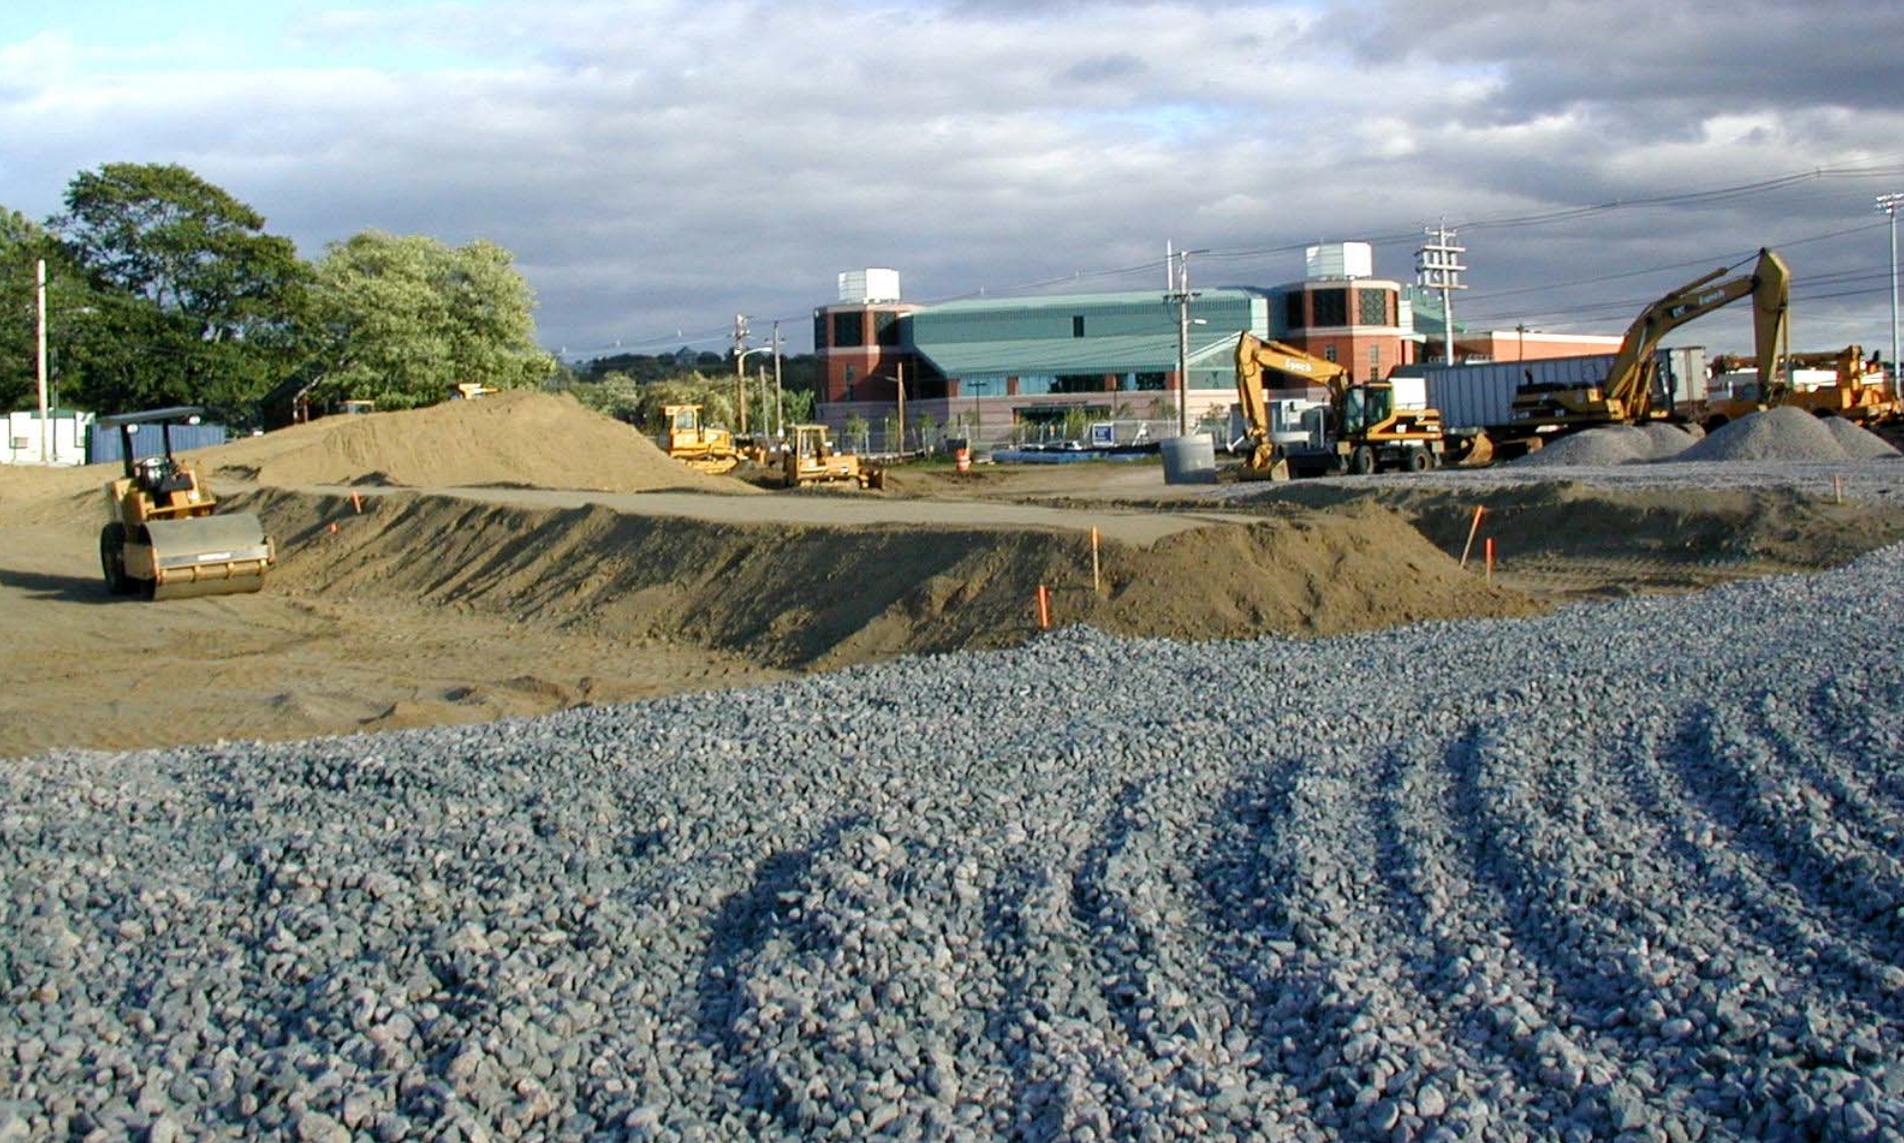
Site preparation is critical!

Remove silt and replace with crushed rock

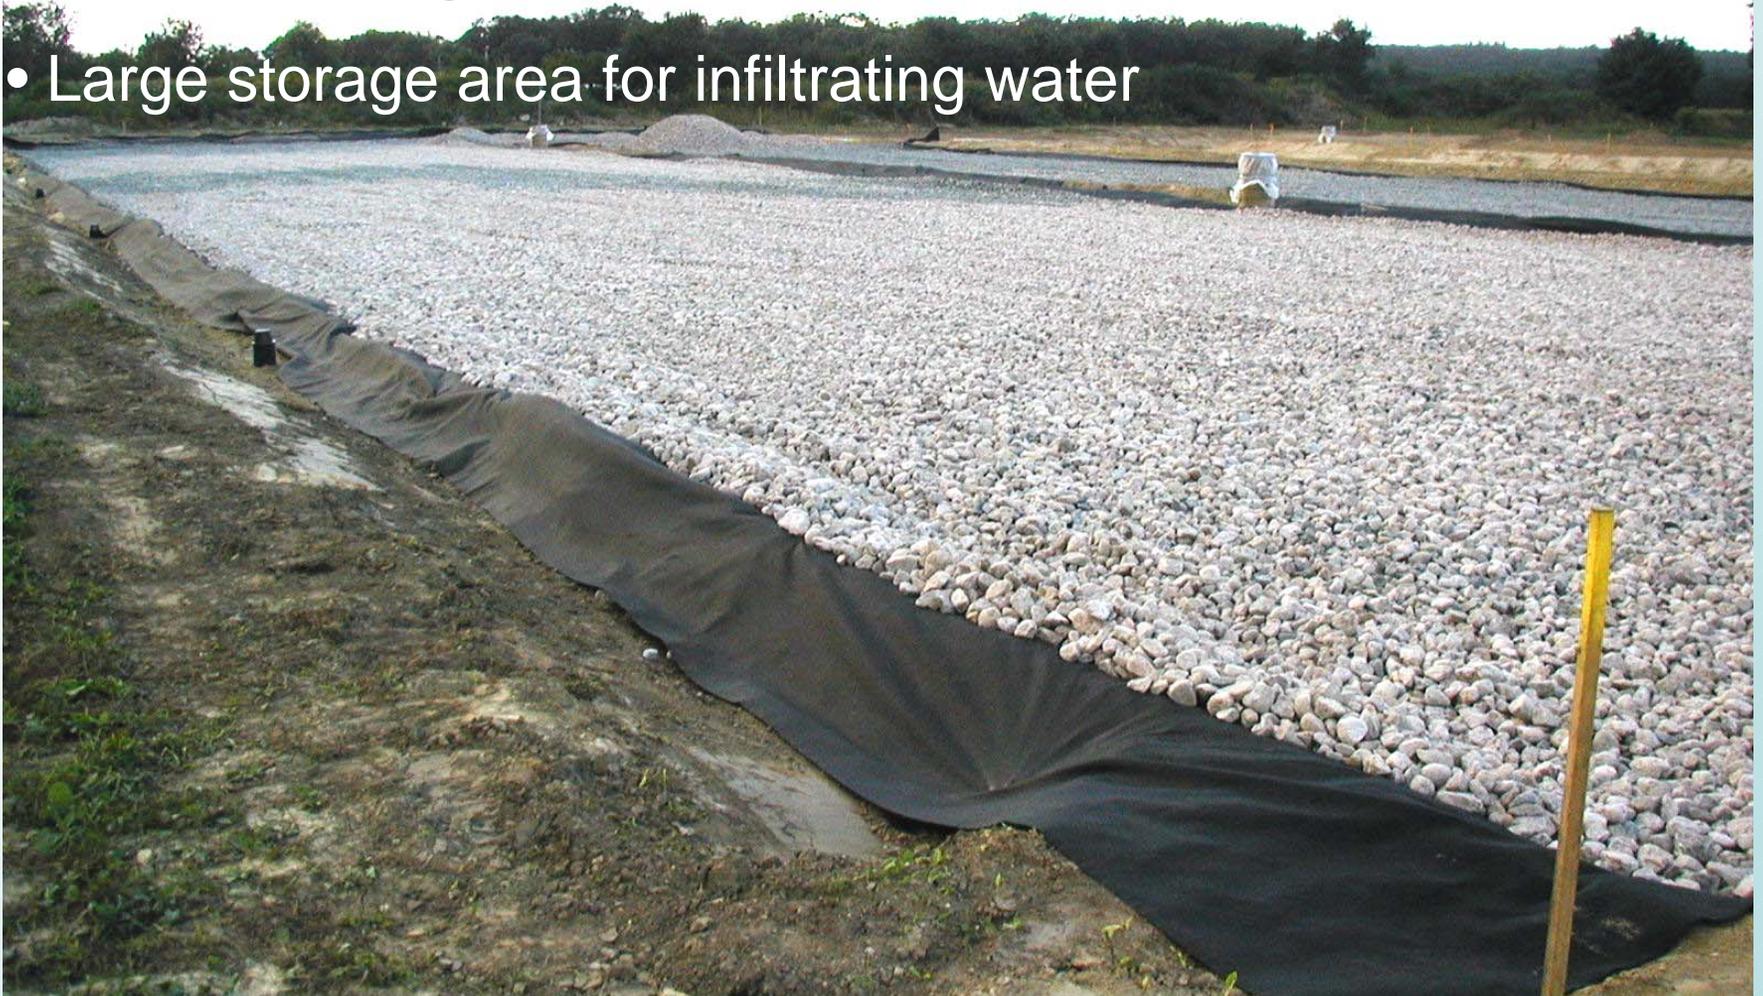
Crushed Rock Provides:

- Stability to asphalt
- Proper drainage
- Large storage area for infiltrating water

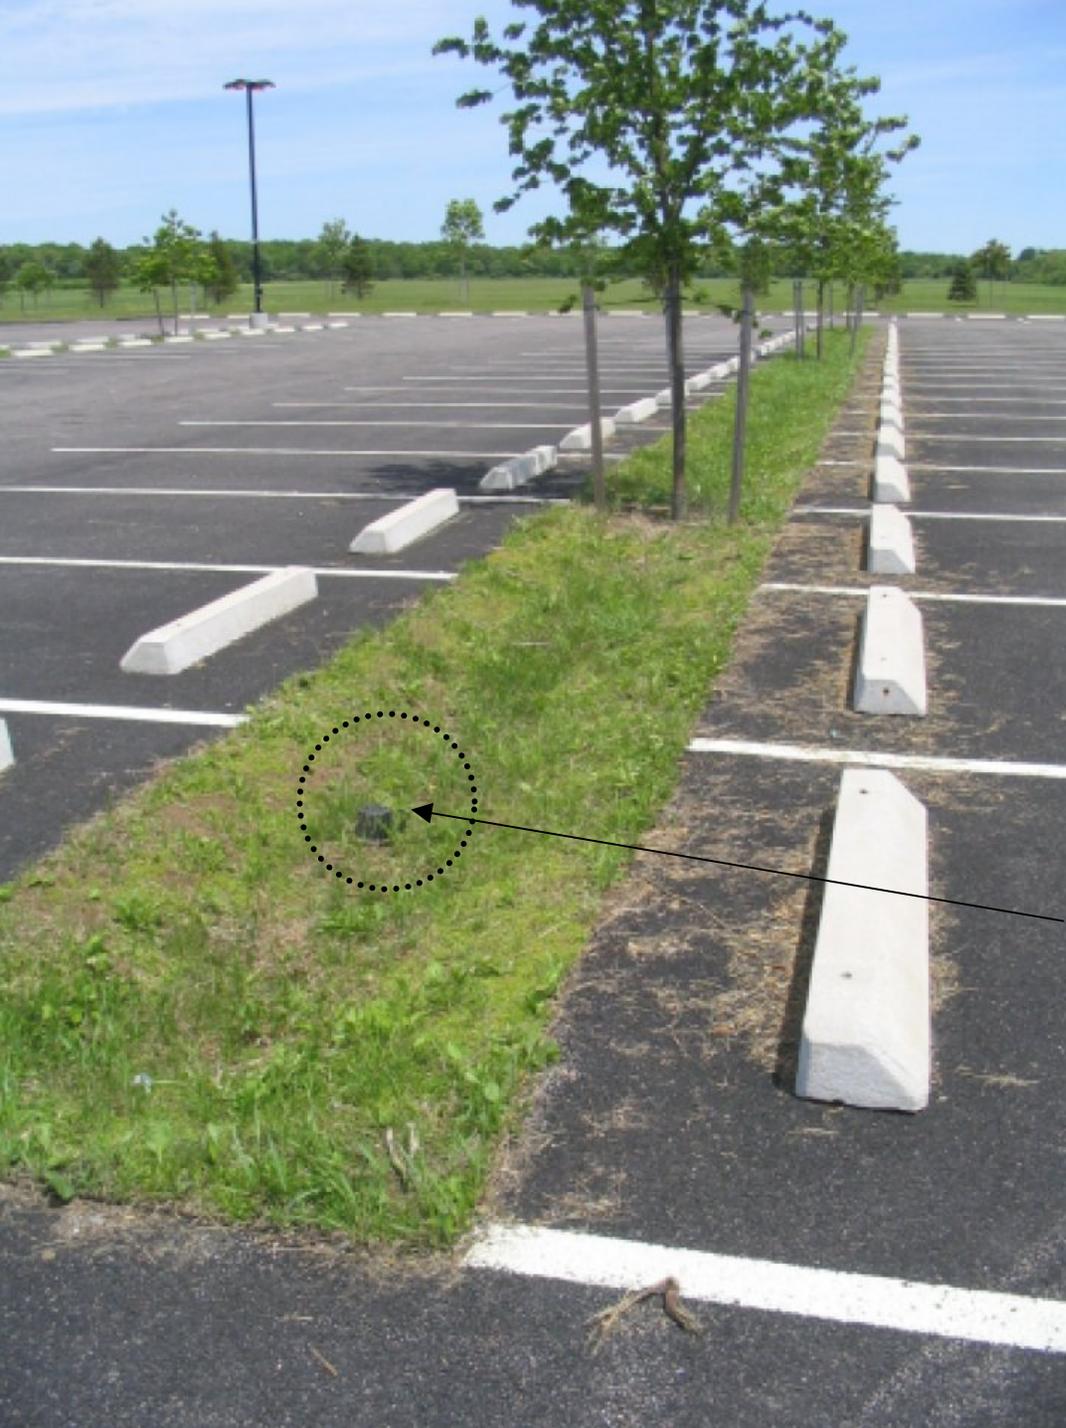
Island Features

- Serve as bioinfiltration areas
- Provide secondary infiltration route during intense rainfall and in case of surface clogging
- 6" risers with clean-out and overflow grates

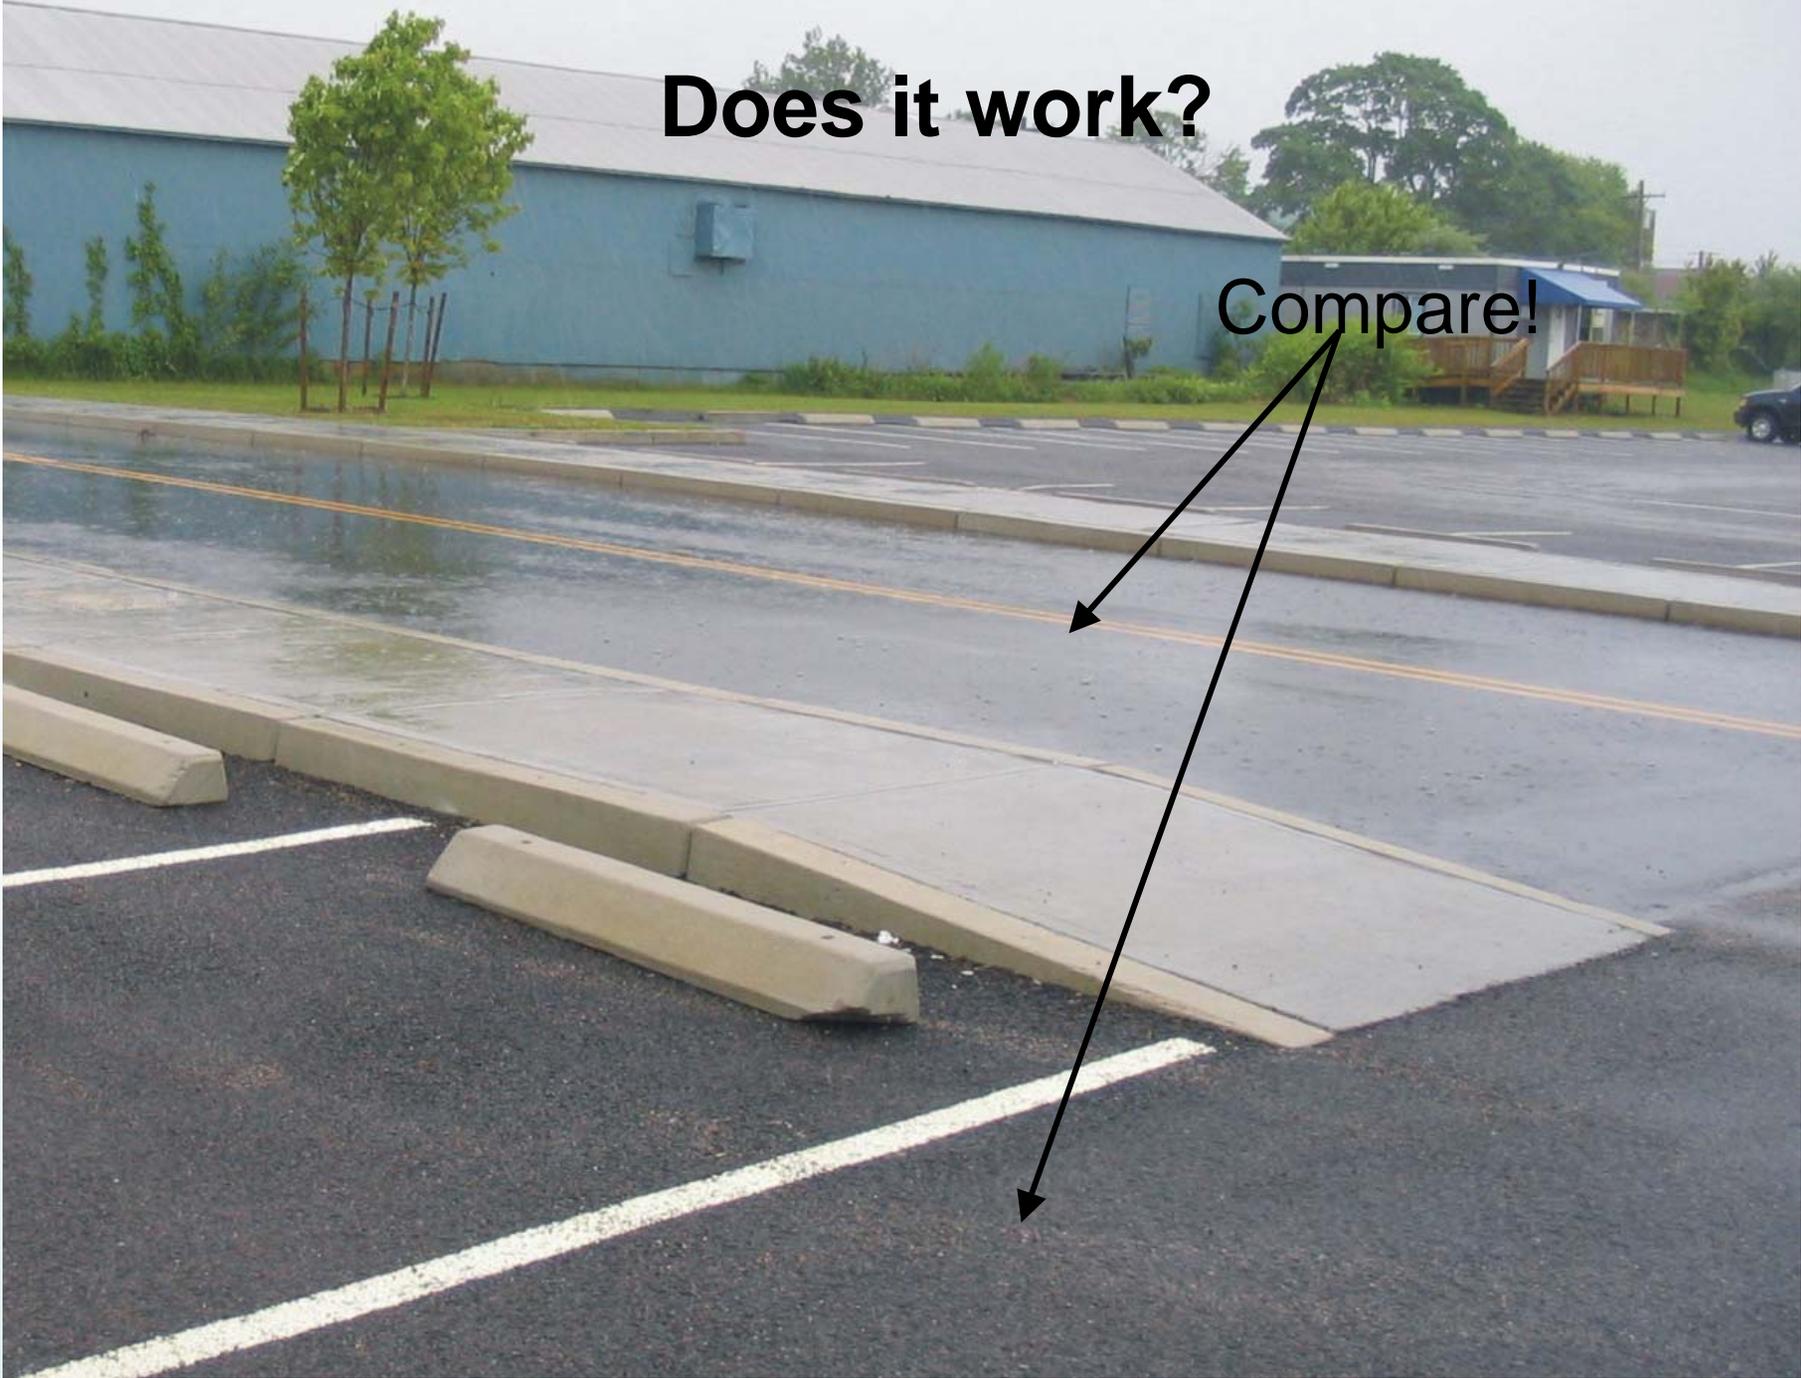
Does it work?

Compare!

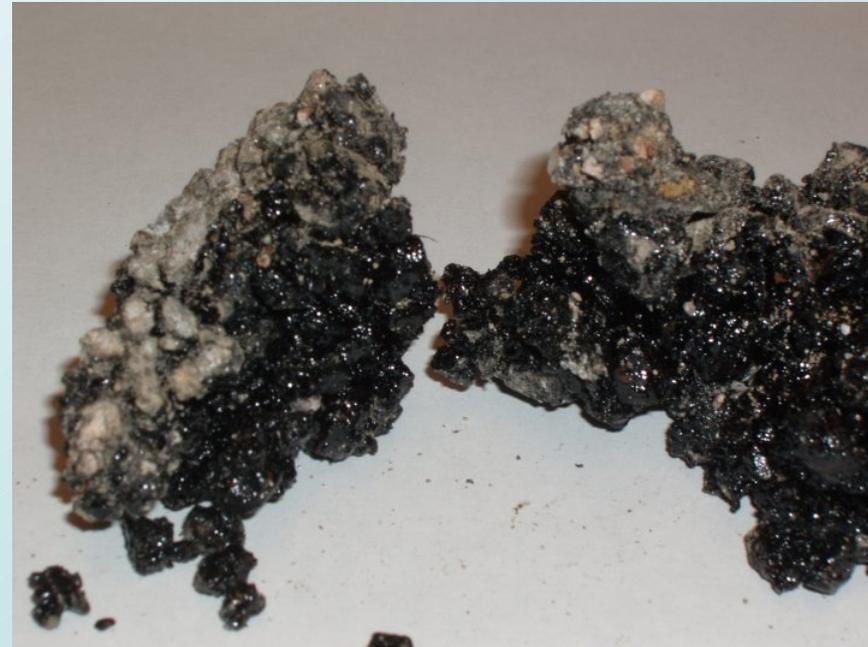
In some areas:
Fine sand clogging asphalt

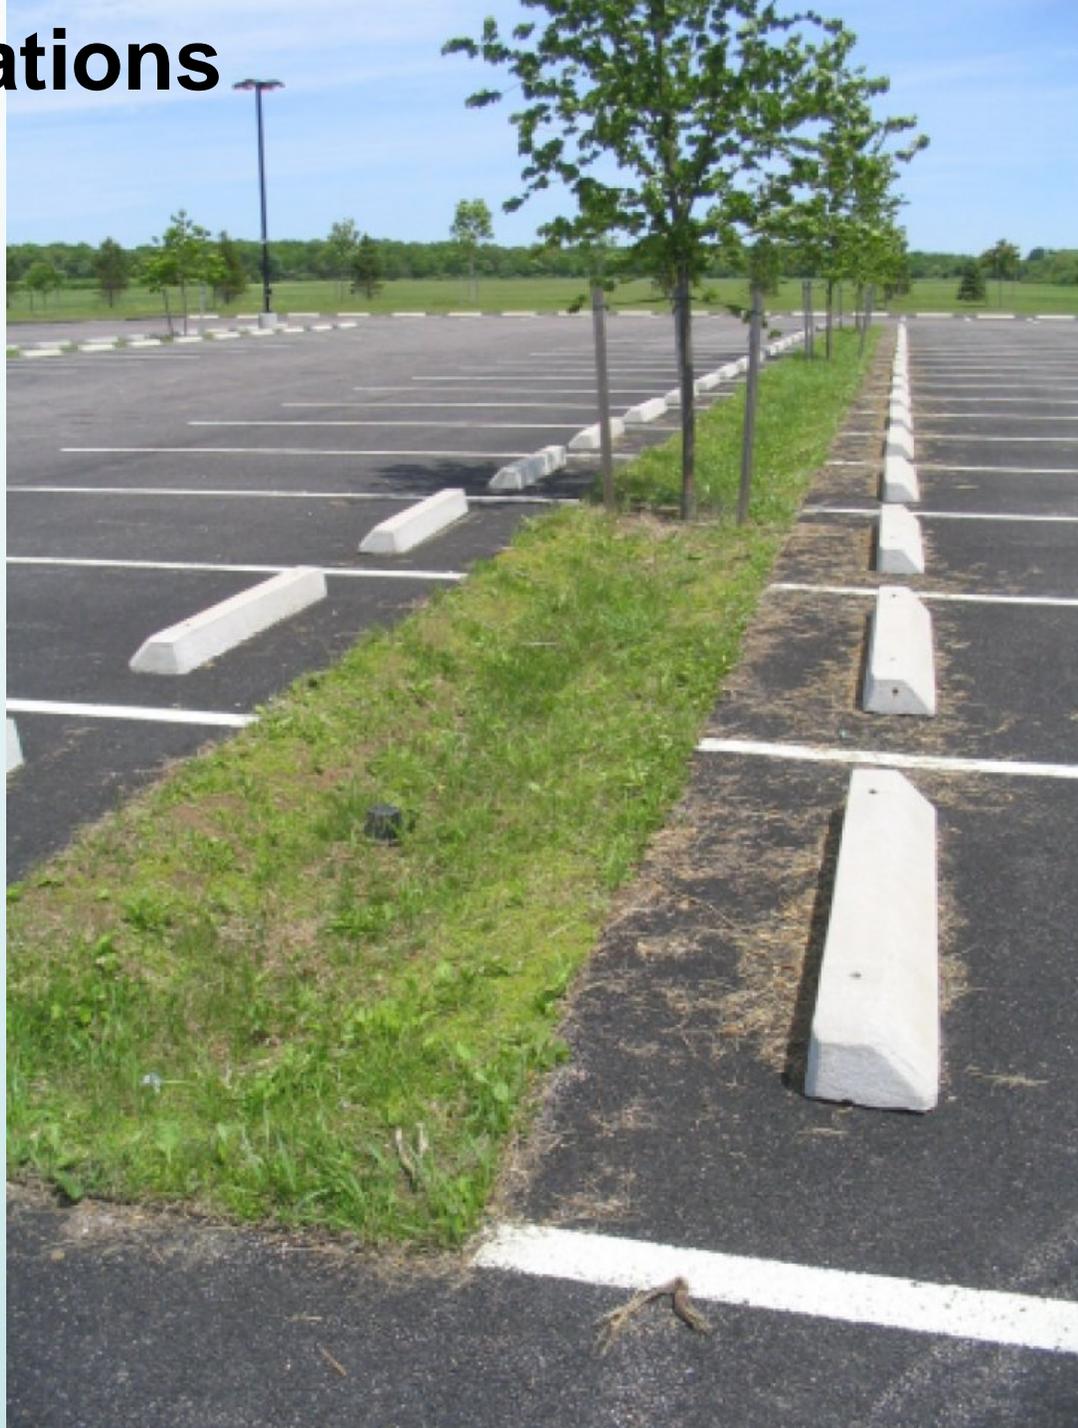
Additional Observations

- Snow stockpiled in corner of lot reduced infiltration due to sands
- Wheel stops moved by plow
- Meadow grasses planted in bioinfiltration areas were high maintenance and eventually mowed
- Some signs of surface clogging in new lot.

- Fewer, wider infiltration islands
- Curb cuts for water entry to island bioinfiltration areas
- Mowed grass, not meadow grasses for islands
- Fewer wheel stops, where possible

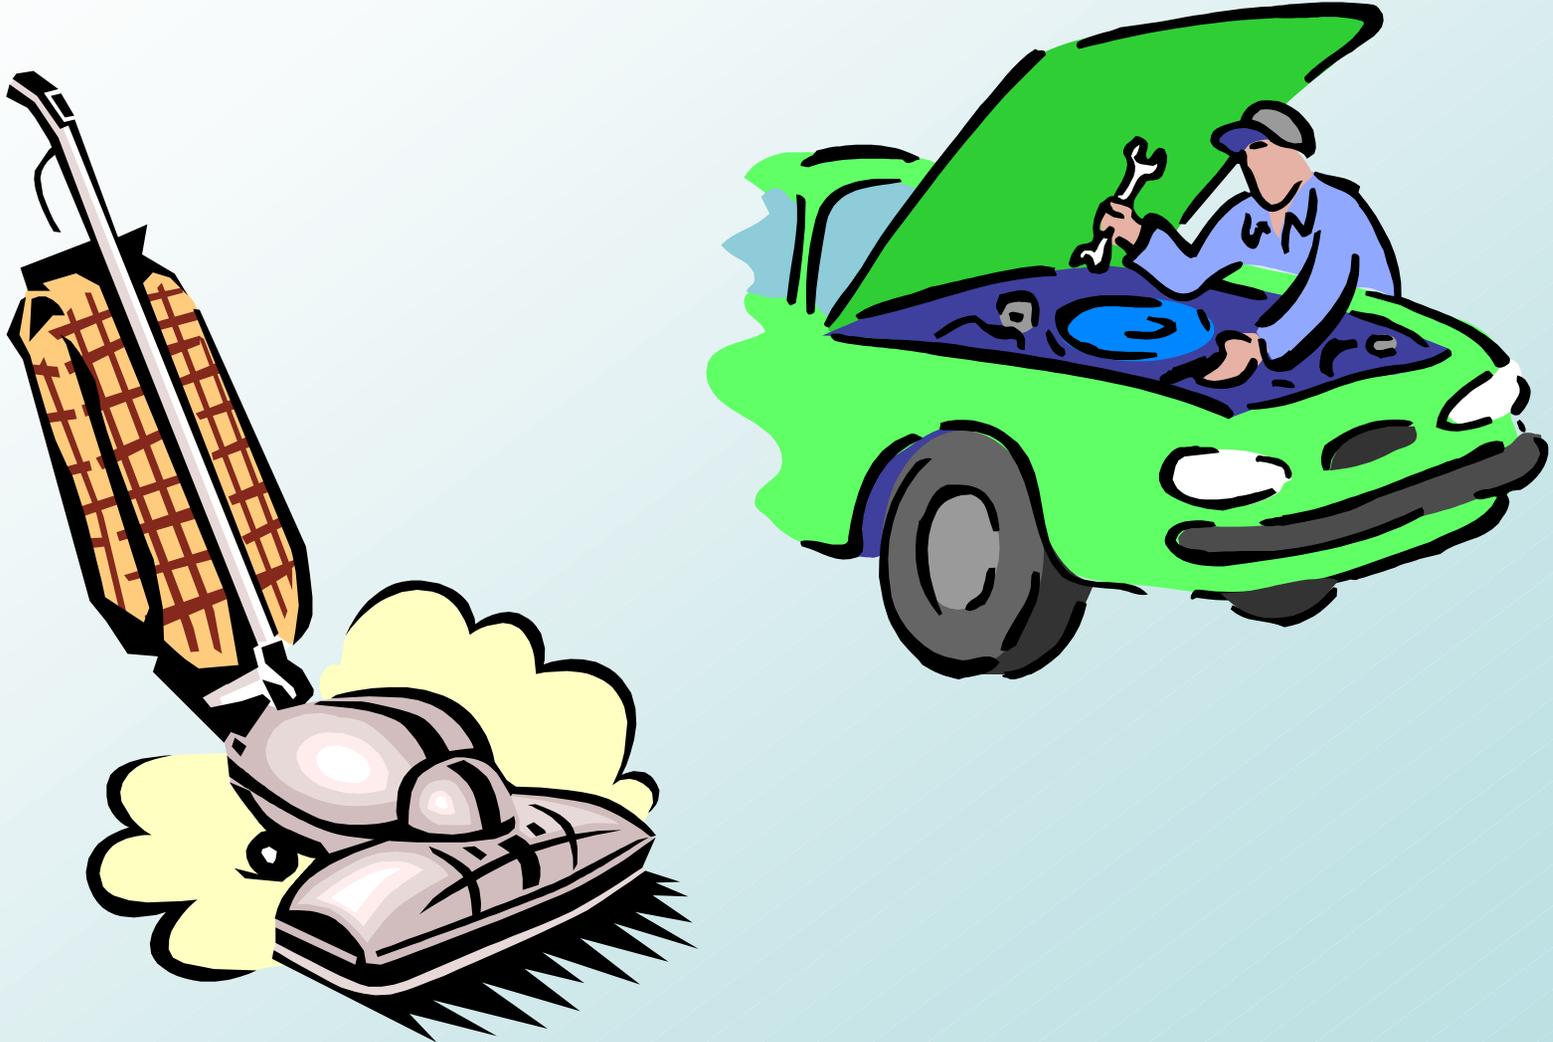
Preventing Clogging

- Vacuum pavement 2 times/year with commercial unit. Do not use brush/wash or compressed air units.
- Maintain planted areas near pavement to avoid bare soil or washouts.
- Mow vegetated islands at least annually. Do not cut to a height less than 4 inches. Remove litter.
- Immediately clean any soil or mulch deposited on pavement.
- Where possible, avoid wind-blown silt from nearby agricultural fields and construction sites.
- Clean inlets draining to subsurface twice/year.

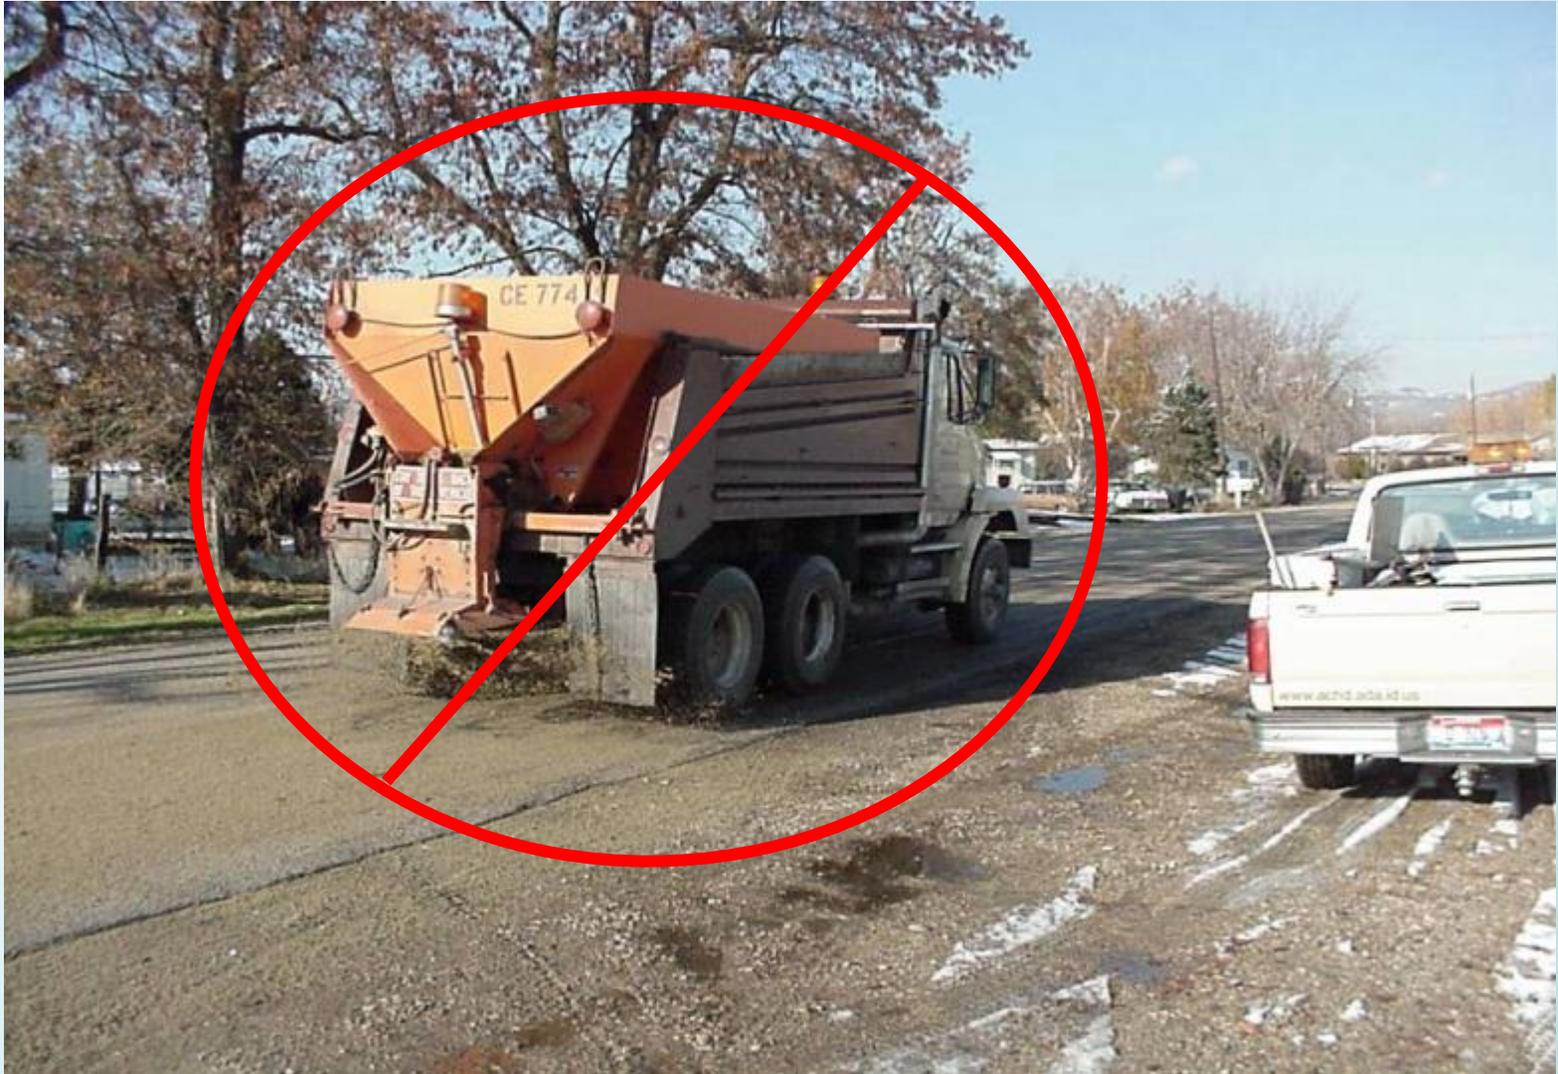
Winter Maintenance

- No sanding.
- No sodium chloride allowed due to wellhead. Use magnesium chloride.
- Raise plow blade 1" higher than normal.
- Do not stockpile snow on pavement.
